RESERVE FUND STUDY

**GASLITE SQUARE CONDOMINIUM
SHERBURN LN
ST MATTHEWS, KY 40207**

On-site Inspection performed September 18, 2024
Submitted October 29, 2024

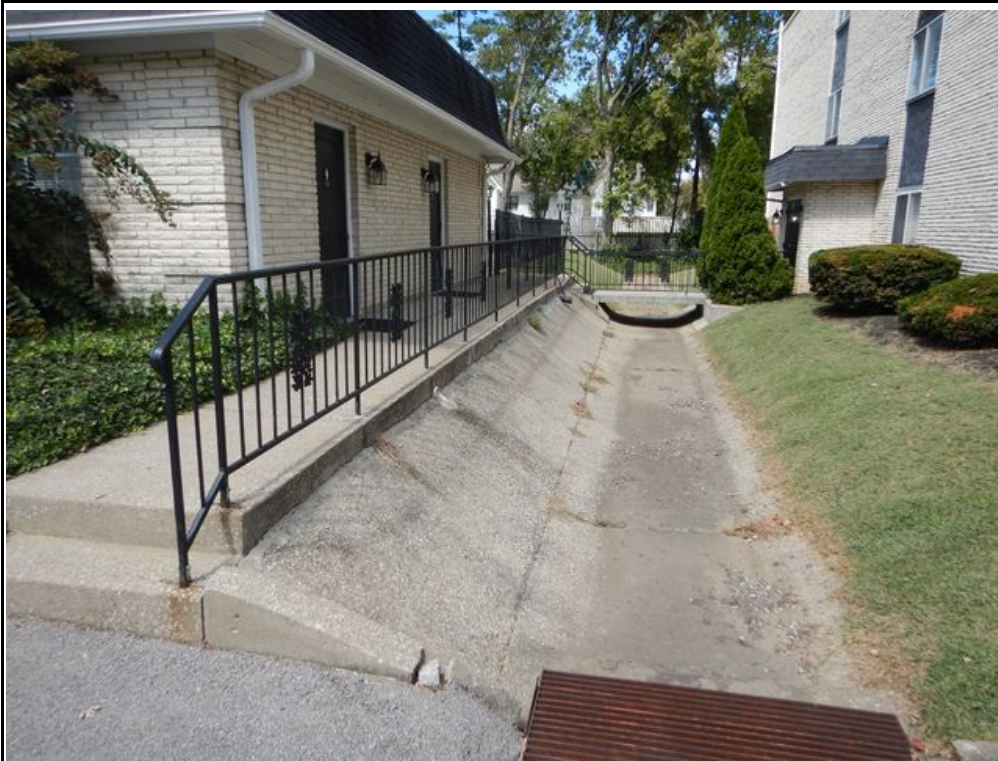
3

We also noted a concrete drainage channel that was not included in this study. As we understand, the concrete channel is part of an easement for water drainage for neighboring sites. It is important for the community to know the responsible party for maintaining the concrete channel.

Concrete drainage channel
appeared to be part of an
easement through the
community

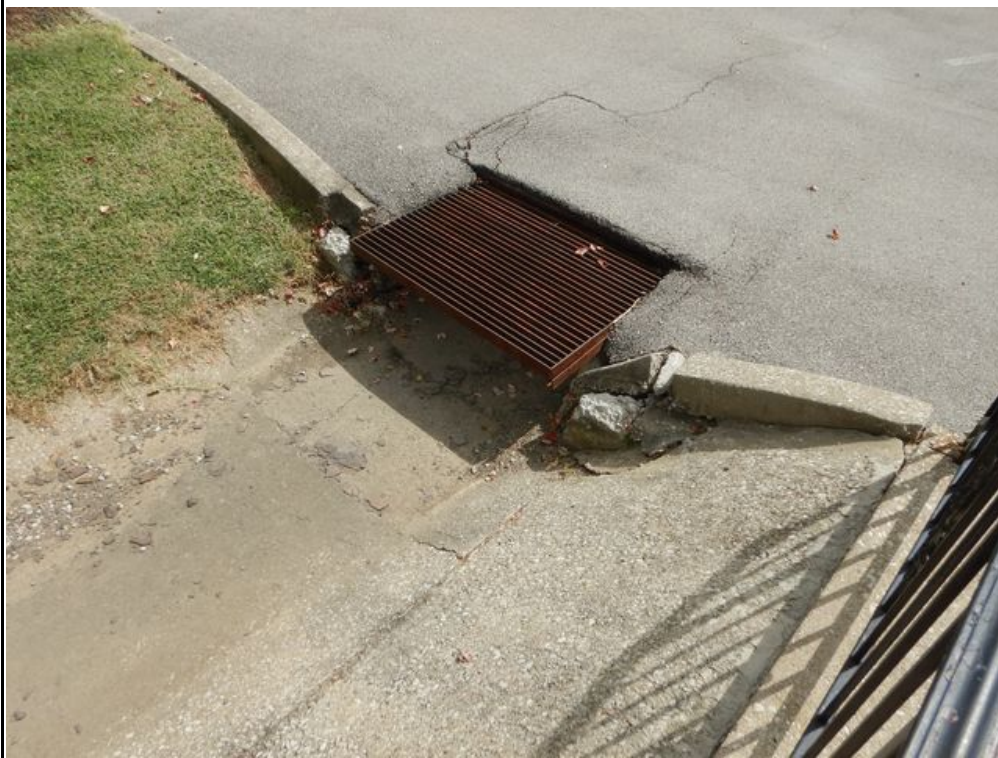
9

Sunken Catch basin in
asphalt surface

The sealing costs should be sufficient for sectional repairs such as raising pavement near storm drains. A&R Concrete Solutions quoted a cost of \$4,230 to repair pavement near storm drains.

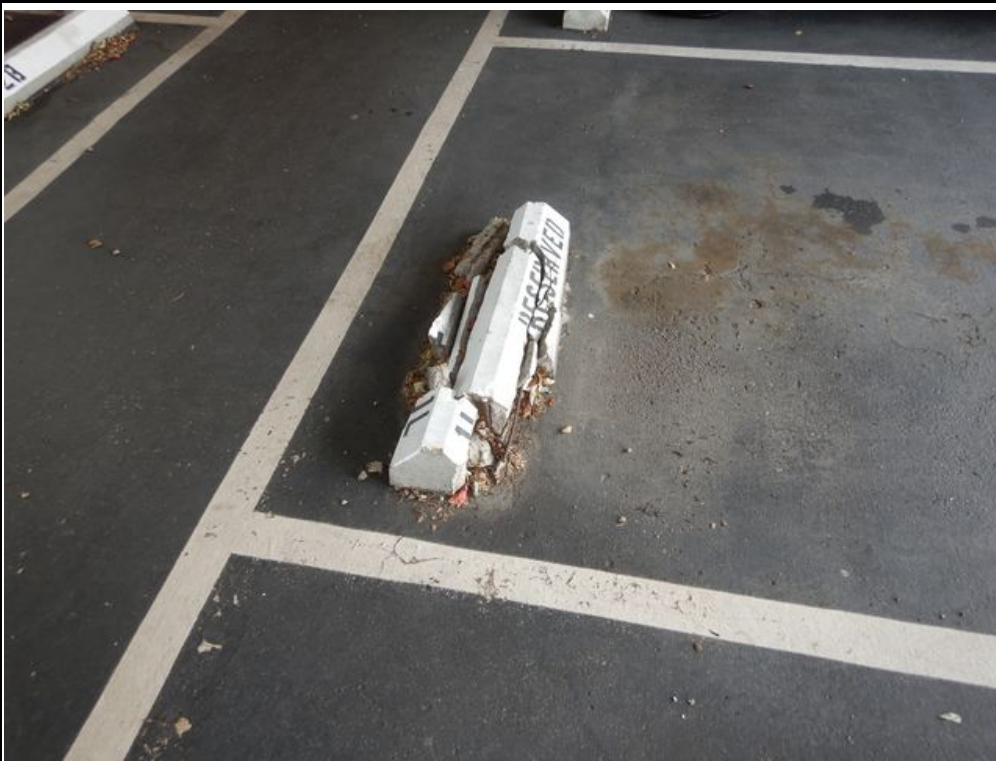
17

Parking stop in poor condition

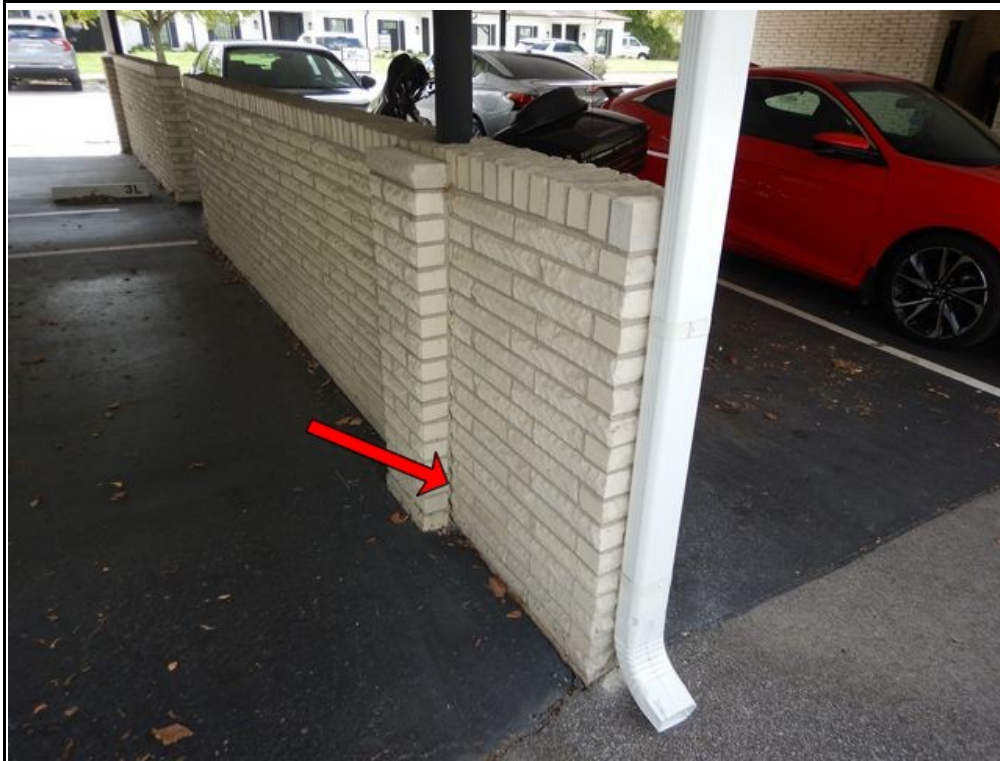
19

Cracks in parking structure
brick walls located near
support columns

We have included an allowance for refurbishment of the carports every 10 years. This could include painting and repair of the carport ceiling, replacement of steel columns, tuckpointing of brick walls, replacement of lighting. We noted rust on the steel columns and cracks in the brick walls near the steel columns. Costs of the carport improvements are subjective and based on our experience with similarly sized structures.

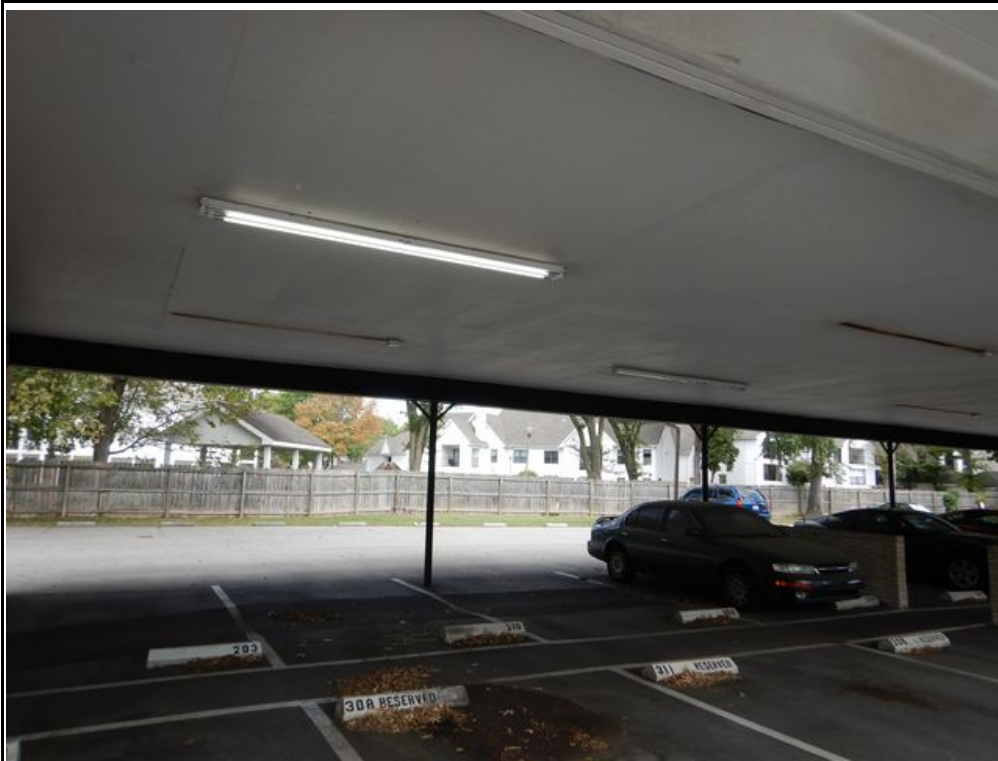
23

Parking structure lighting in
poor condition

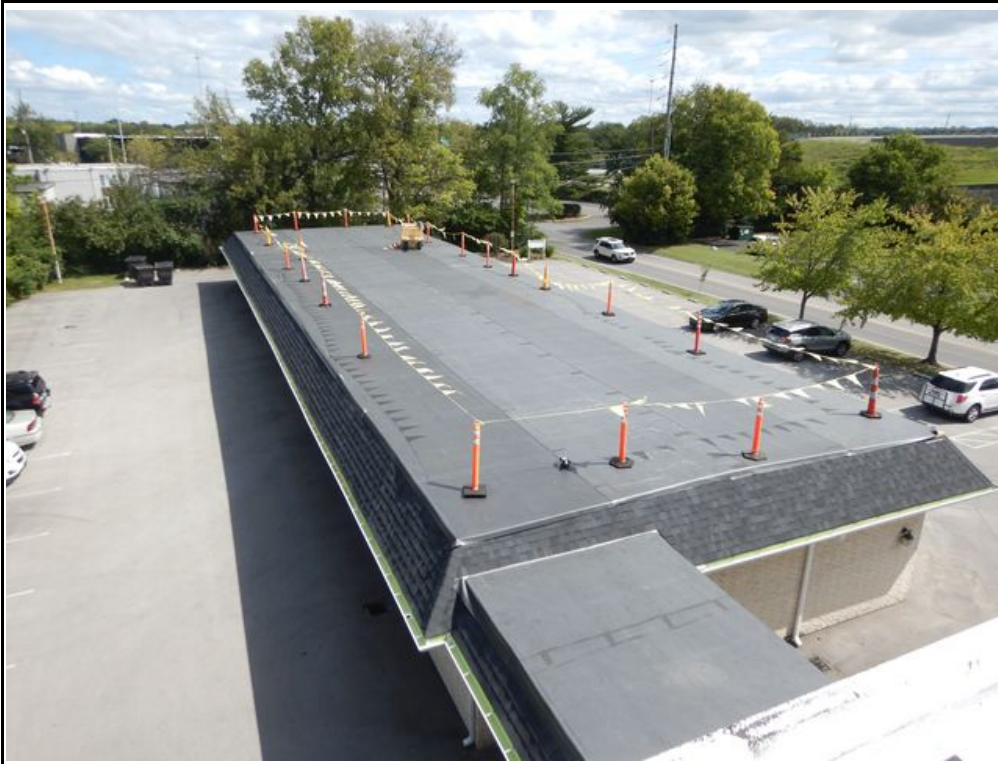
25

Parking structure with roof replacement in process

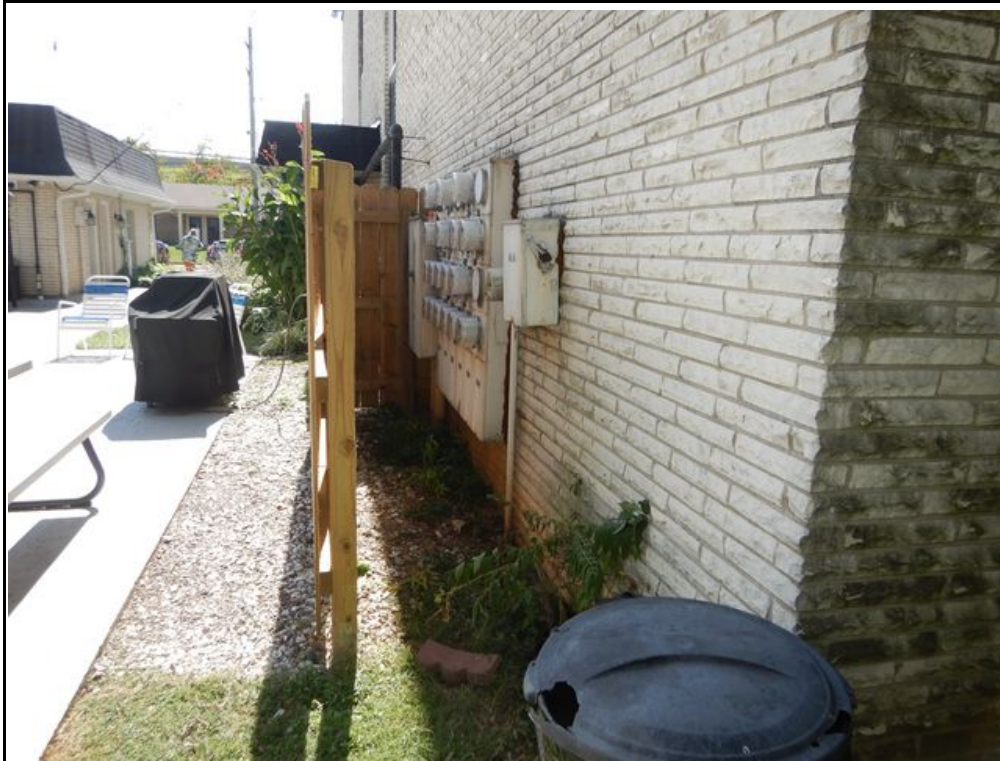
33

Electric distribution equipment in this building was observed to be Federal Pacific electric panels. These are safety issues that are known potential fire risks. The recommended correction is to replace the electric panels. Schell Electric Co quoted replacement of the clubhouse breaker panel and Building B's electric meters. We separated the replacement into phases over the next 6 years.

Electric meters and Federal Pacific electrical equipment

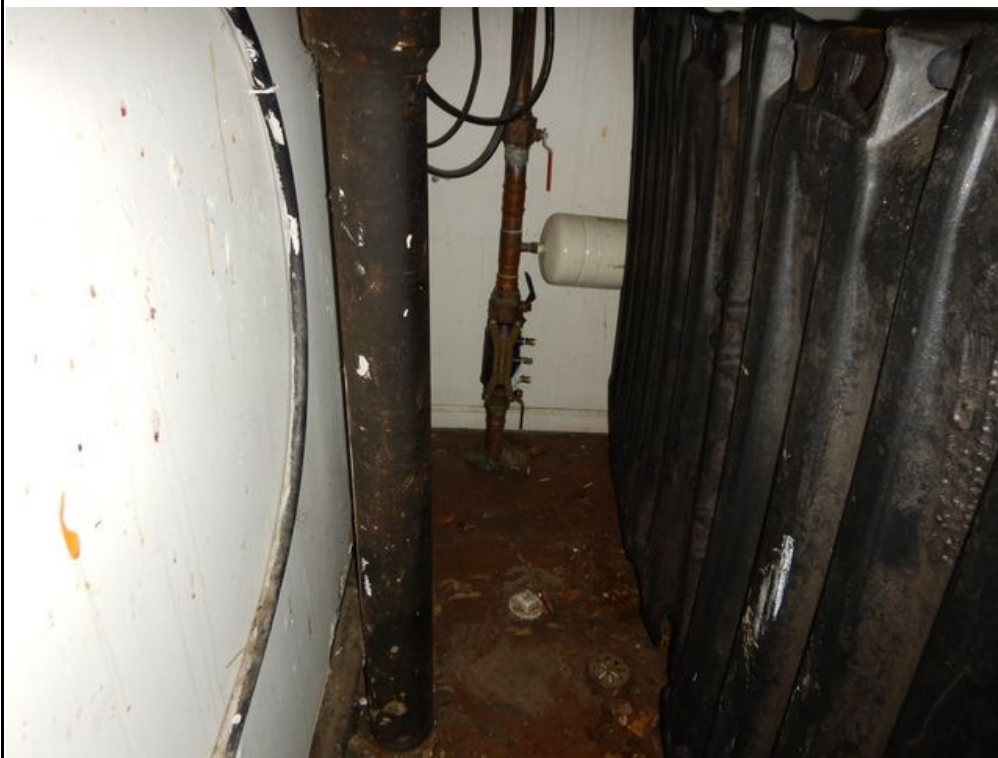
49

The plumbing in this community is cast iron. We do not do condition assessments of components we cannot see such as buried water laterals. Cast iron has a useful lifespan of about 50 years. The community has had issues with their cast iron plumbing and has replaced some sections. We have included costs to replace all cast iron piping in the

Cast iron drain piping and
copper supply piping

buildings based on the total area of the buildings. Costs of the cast iron replacement are subjective and based on our experience with similarly sized communities. Replacement of cast iron will also require repairs to interior finishes that cover the plumbing.

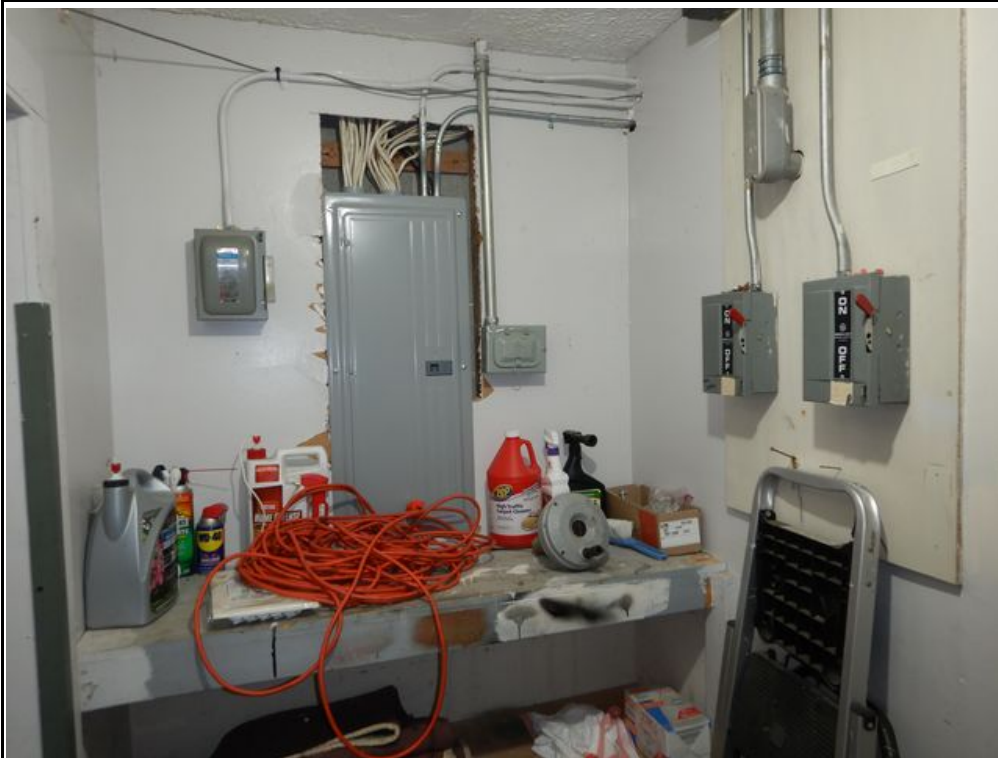
55

Breaker box that has been replaced
