RESERVE FUND STUDY

**GASLITE SQUARE CONDOMINIUM
SHERBURN LN
ST MATTHEWS, KY 40207**

On-site Inspection performed September 18, 2024
Submitted October 29, 2024

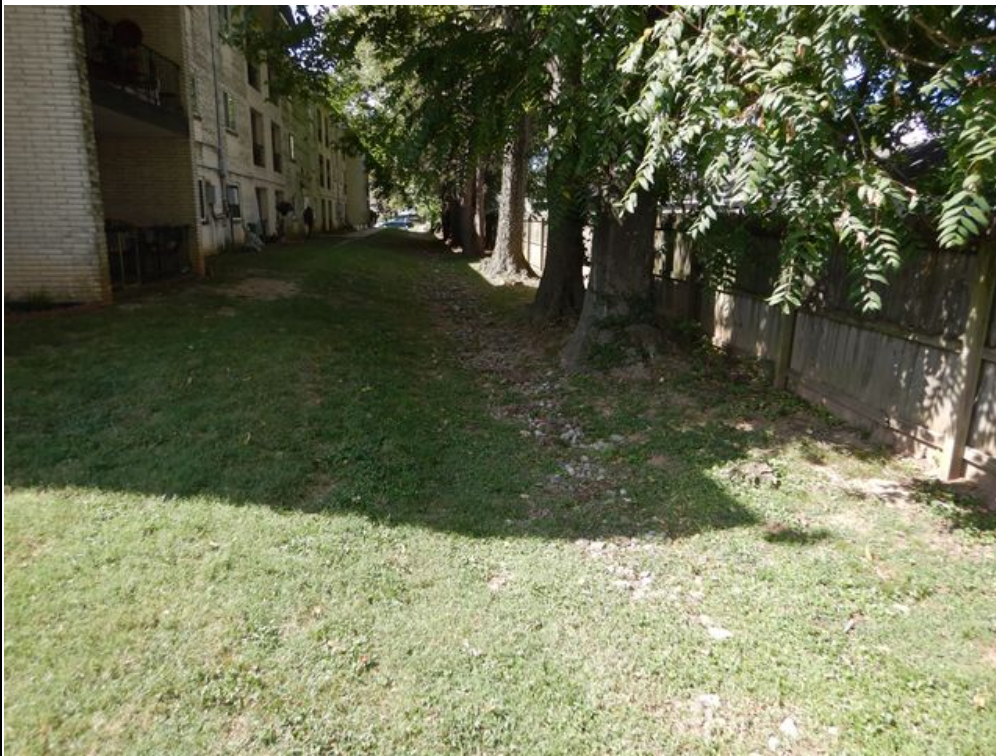
5

French drain along rear of
Building B with reported
drainage issues

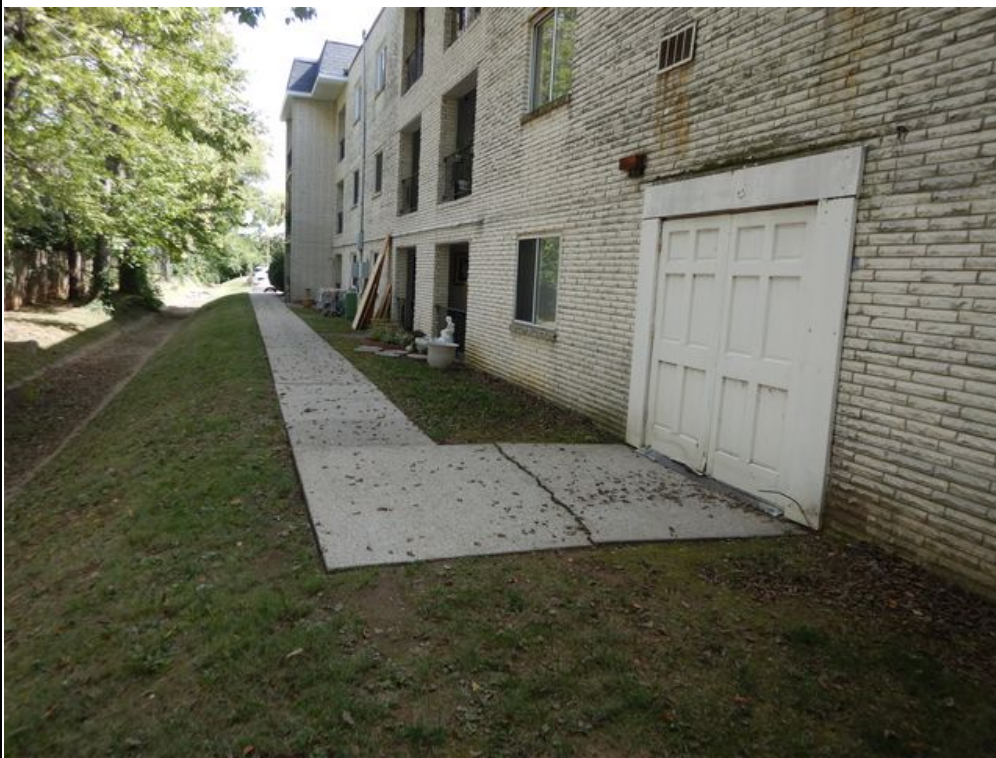
7

Typical concrete walkway

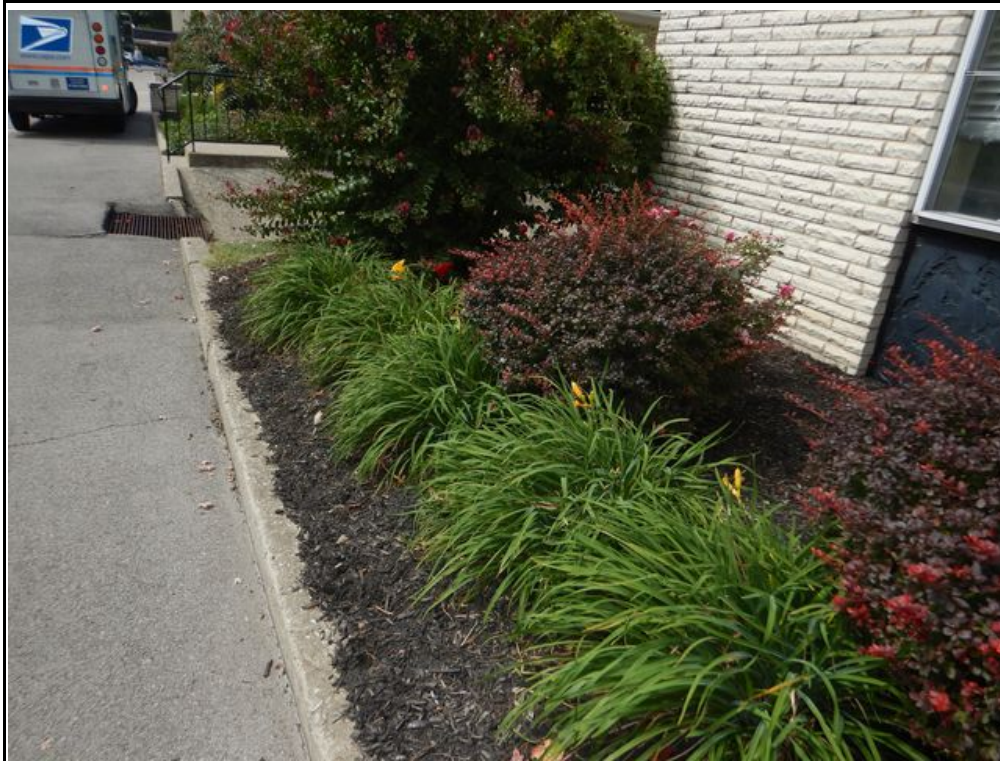
11

Flowerbeds along front of
buildings

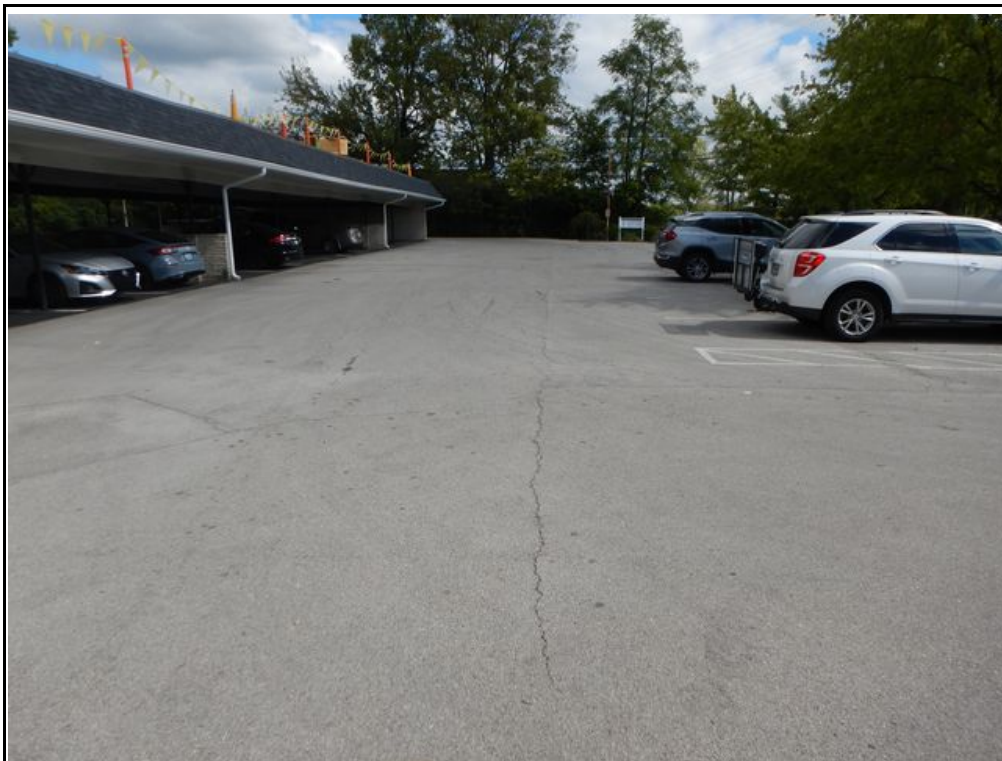
13

General view of parking area

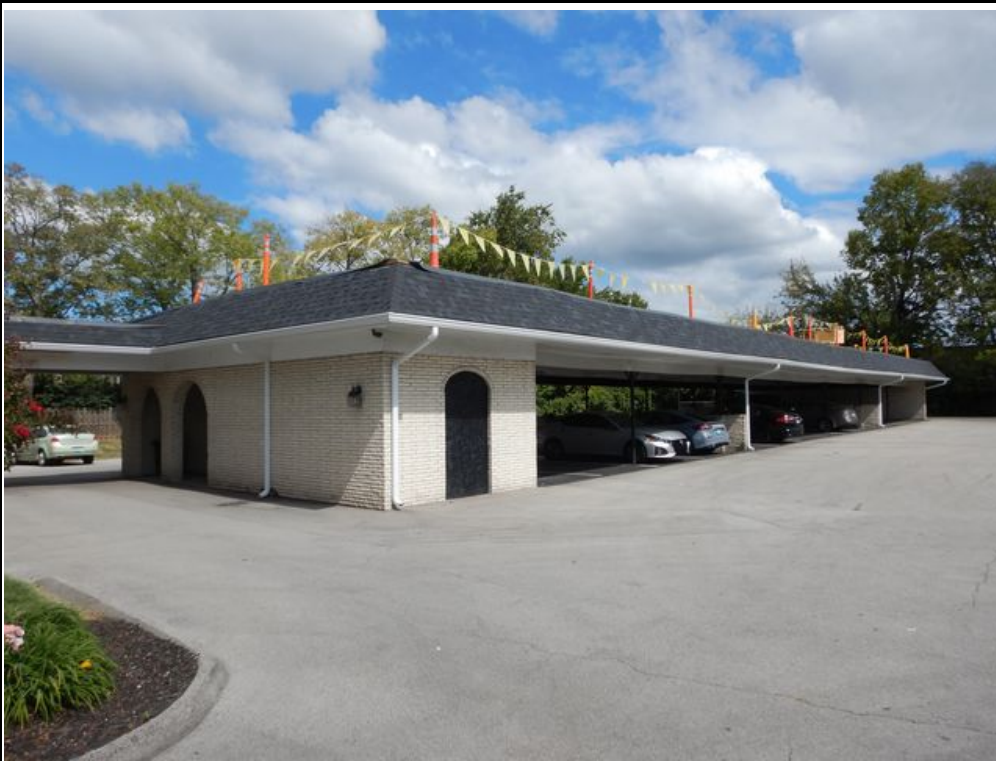
15

Example of a parking structure

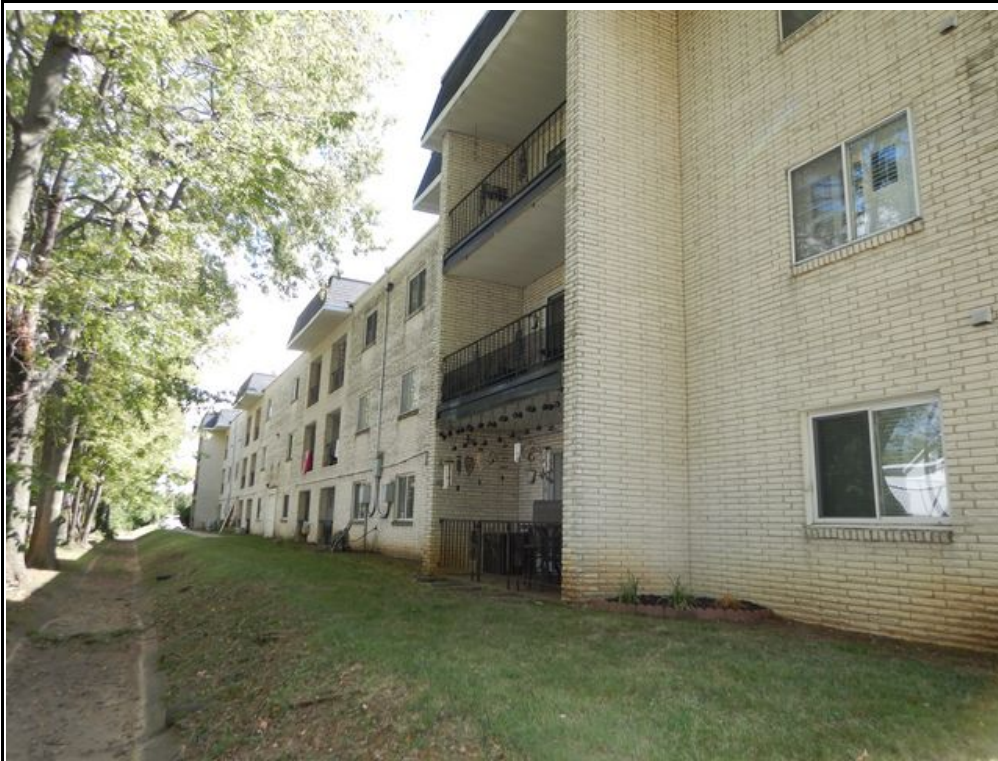
27

Rear view of residential
building

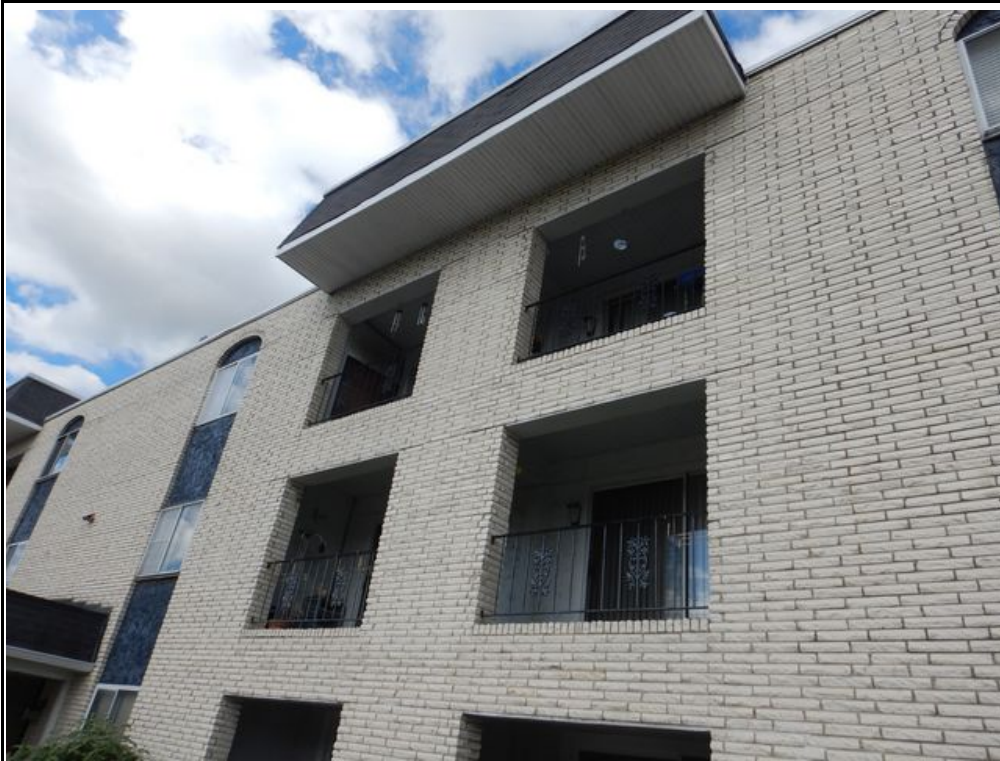
29

Balconies

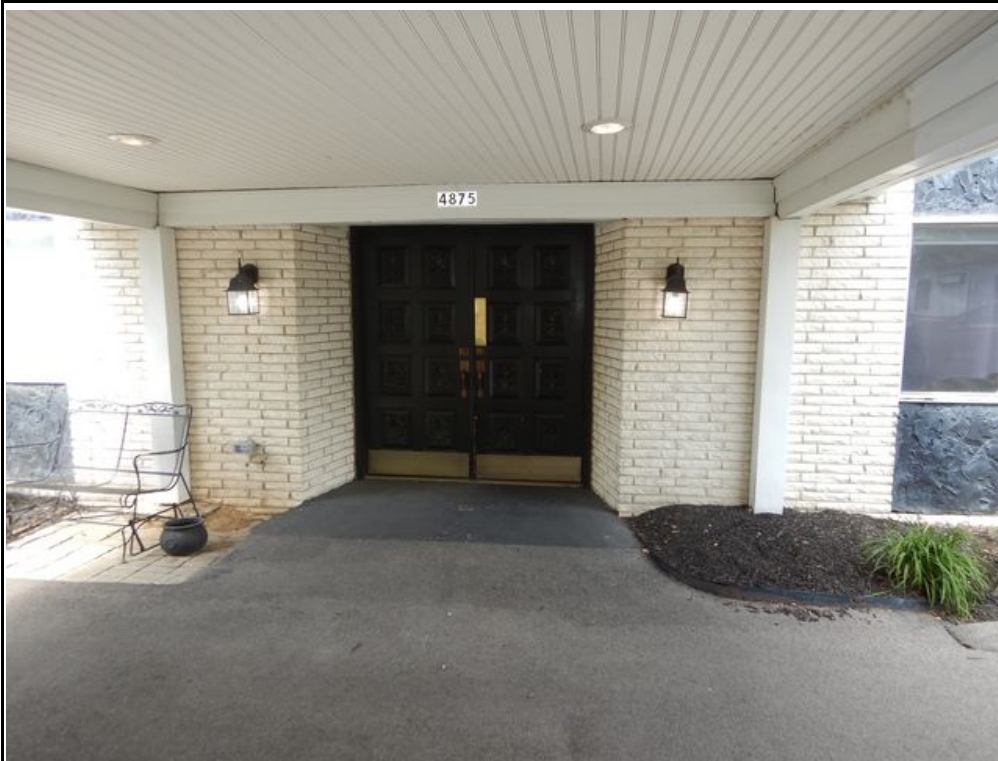
31

Main entrance to residential
building

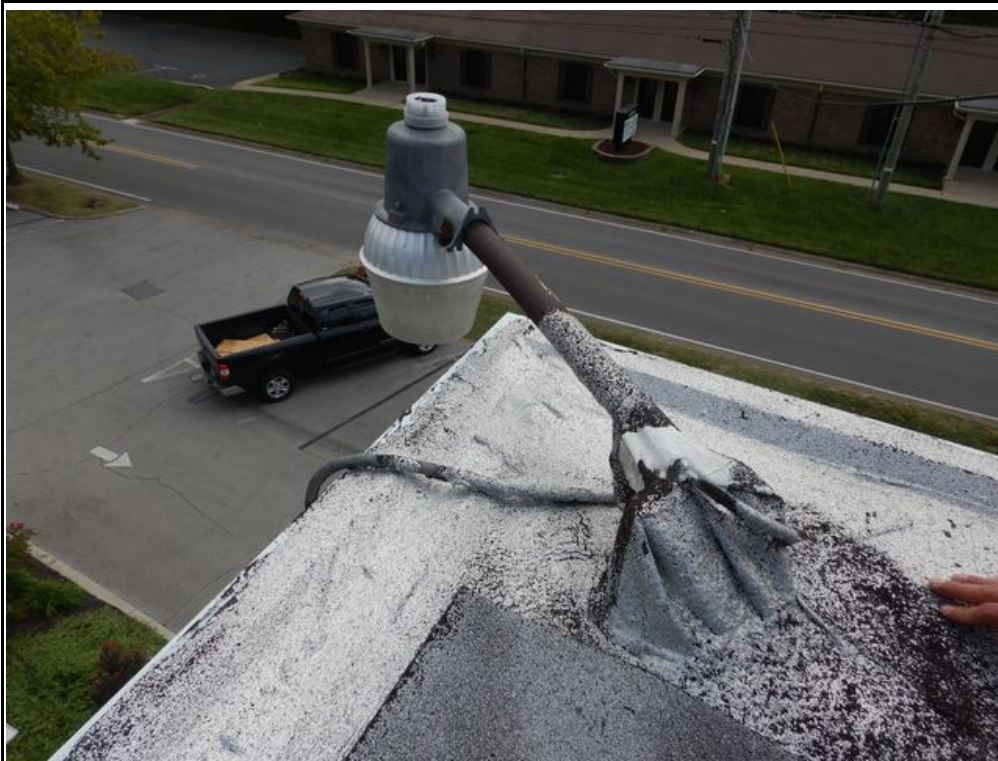
35

Residential building exterior
lighting

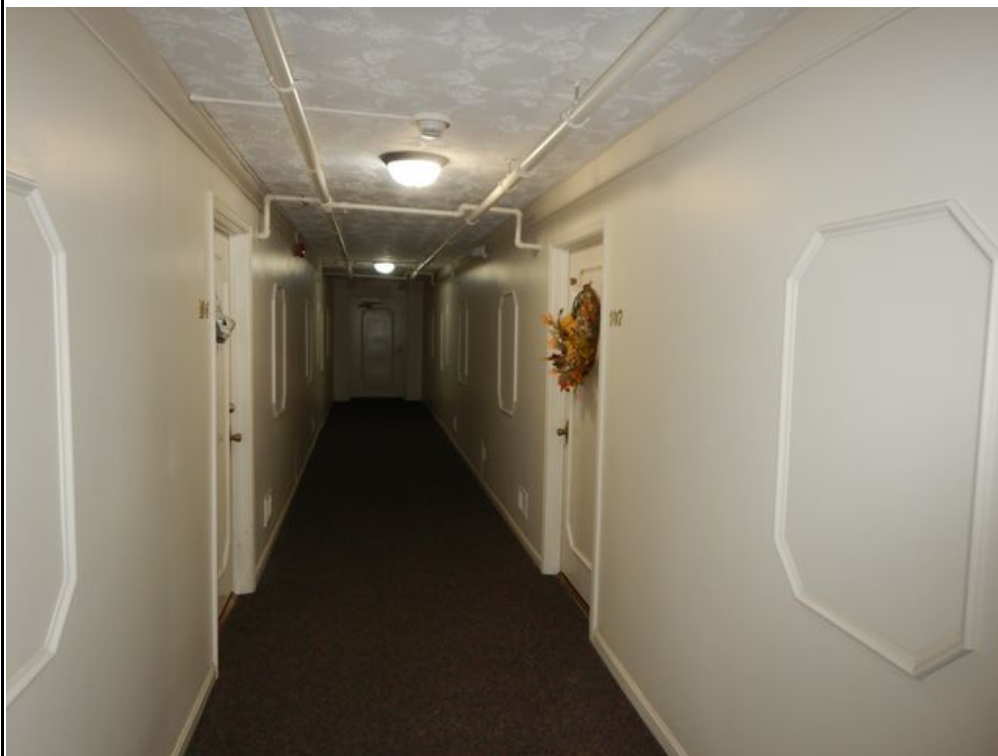
37

Typical common hallway

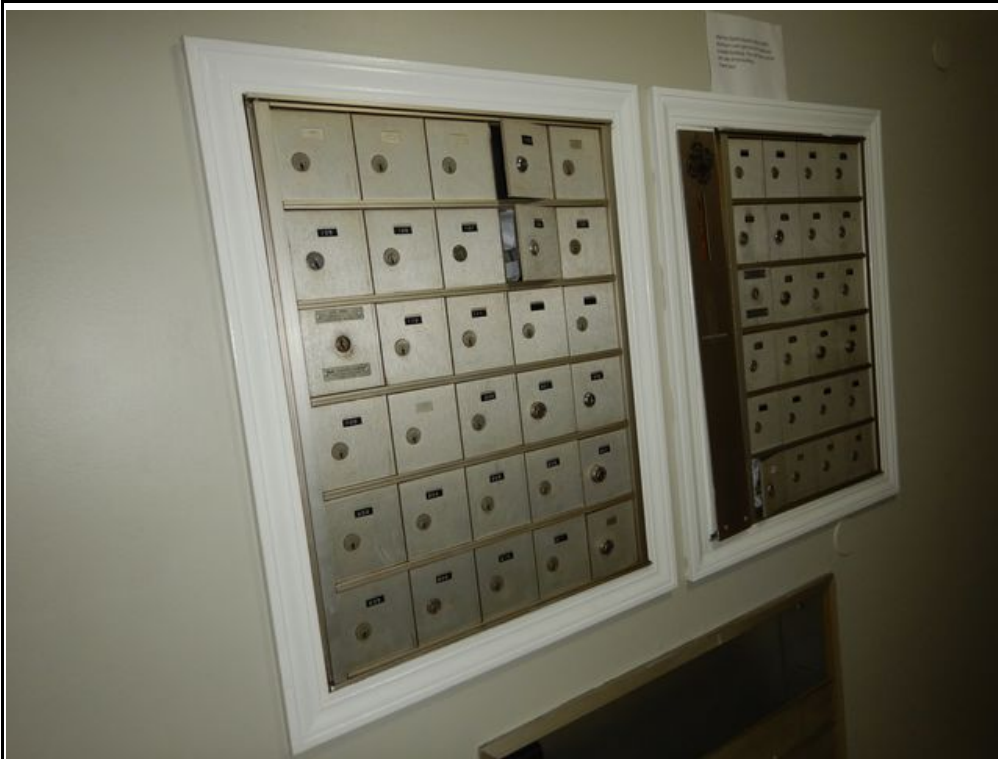
39

Mailboxes

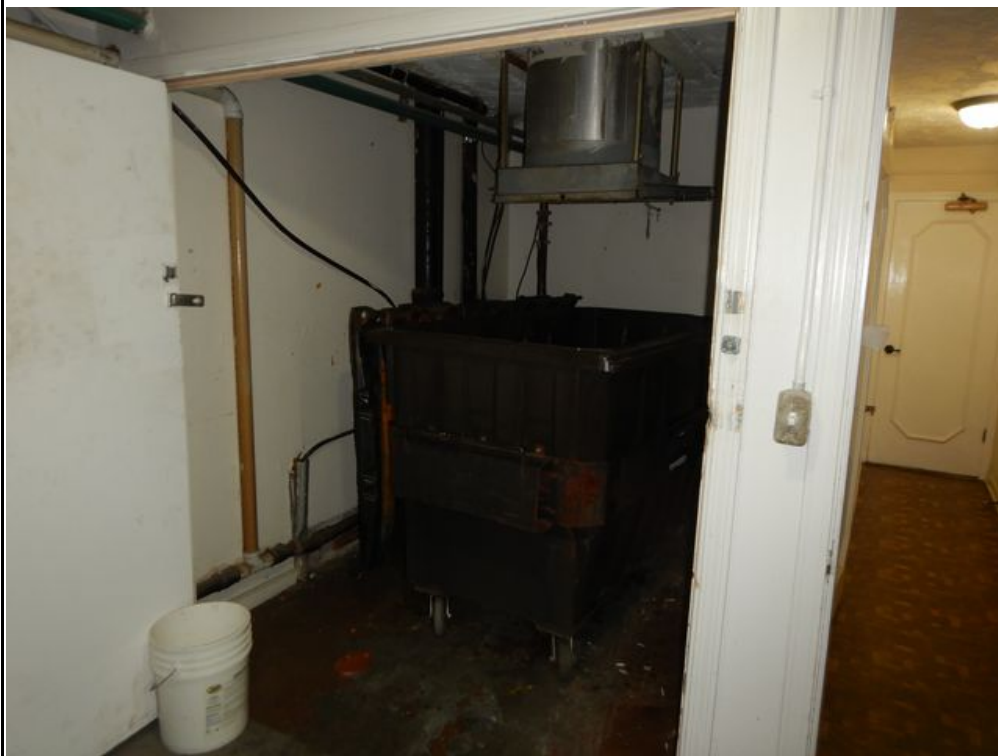
Photo Number

Garbage chute

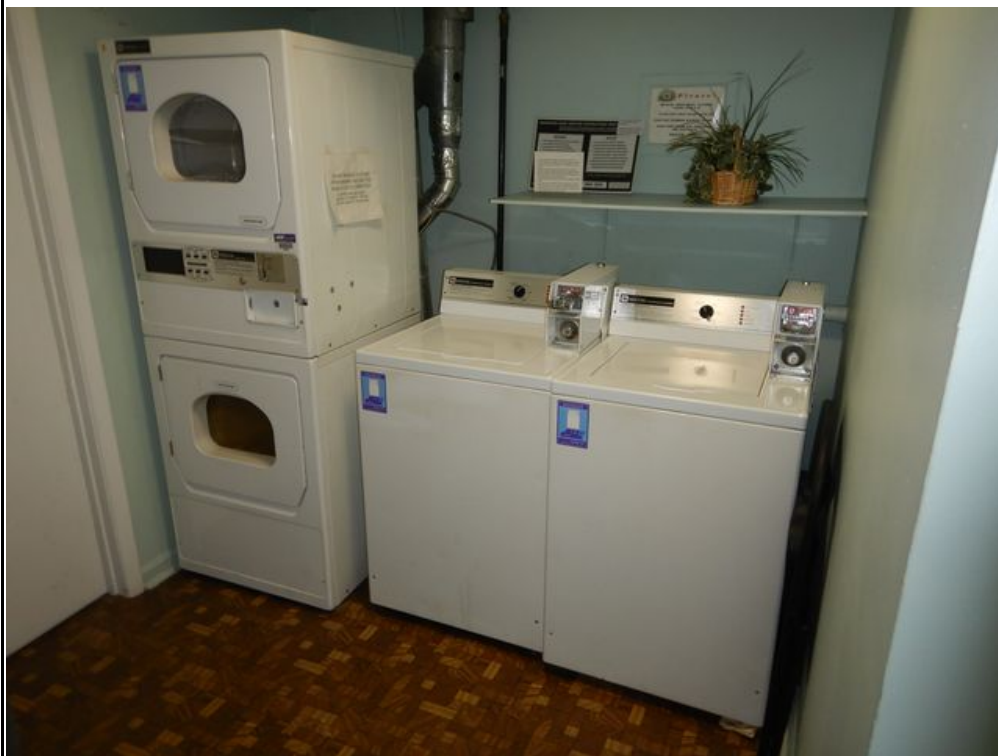
Photo Number

Laundry room

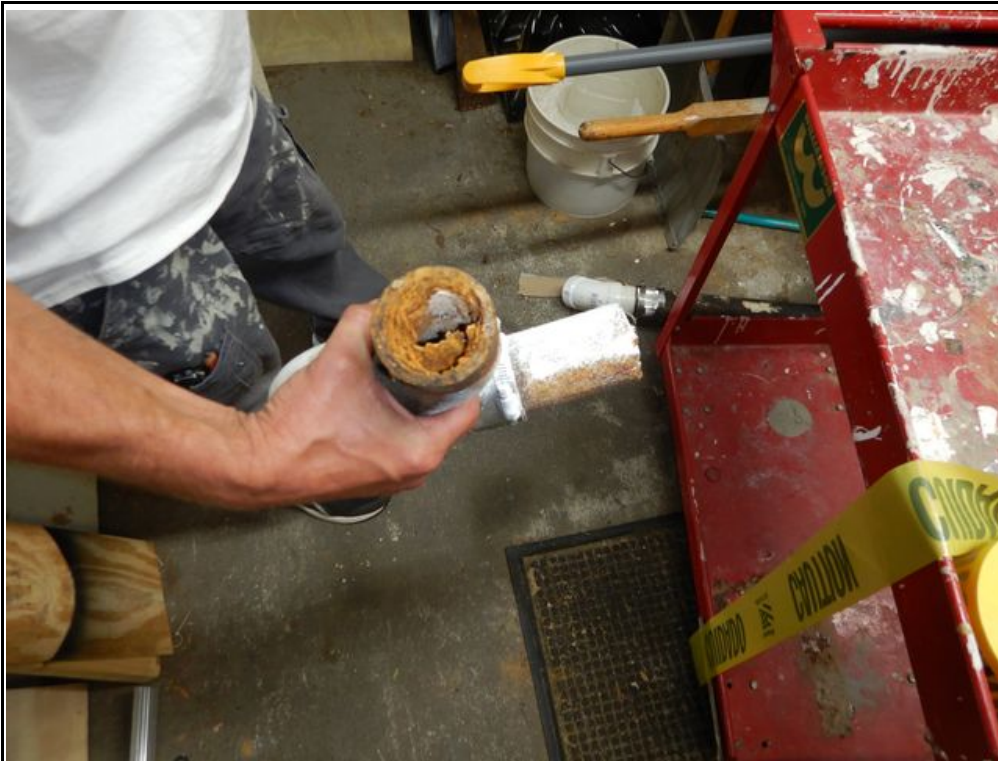
Photo Number

Example of old cast iron
piping that was replaced

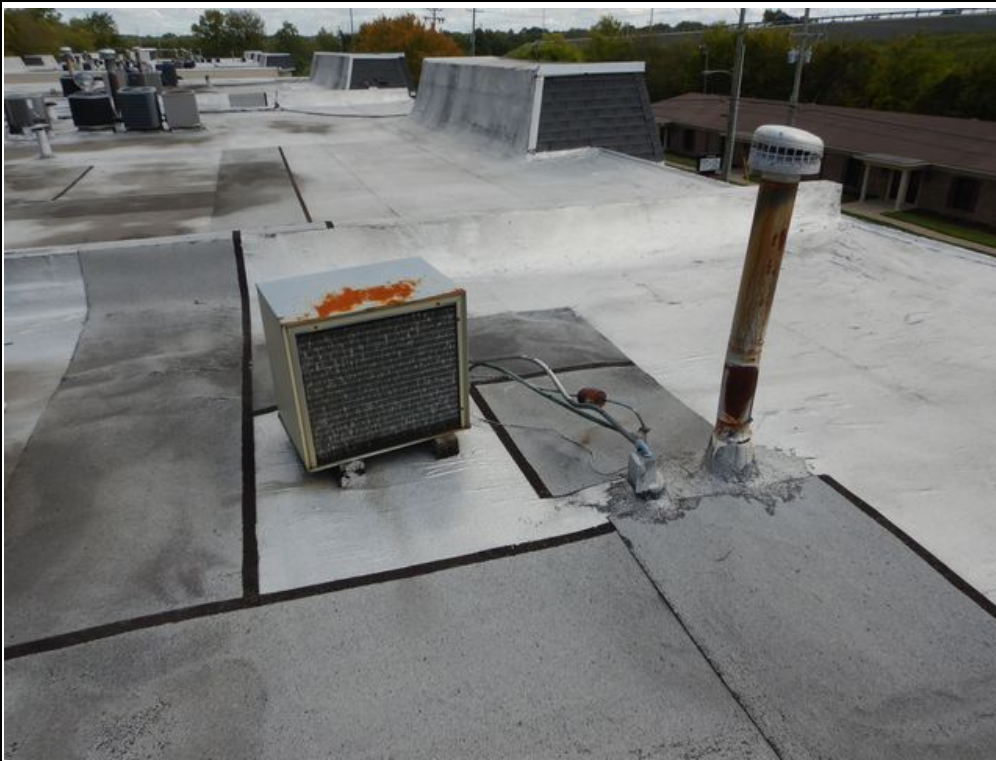
Photo Number

Rooftop condensing unit for
common areas

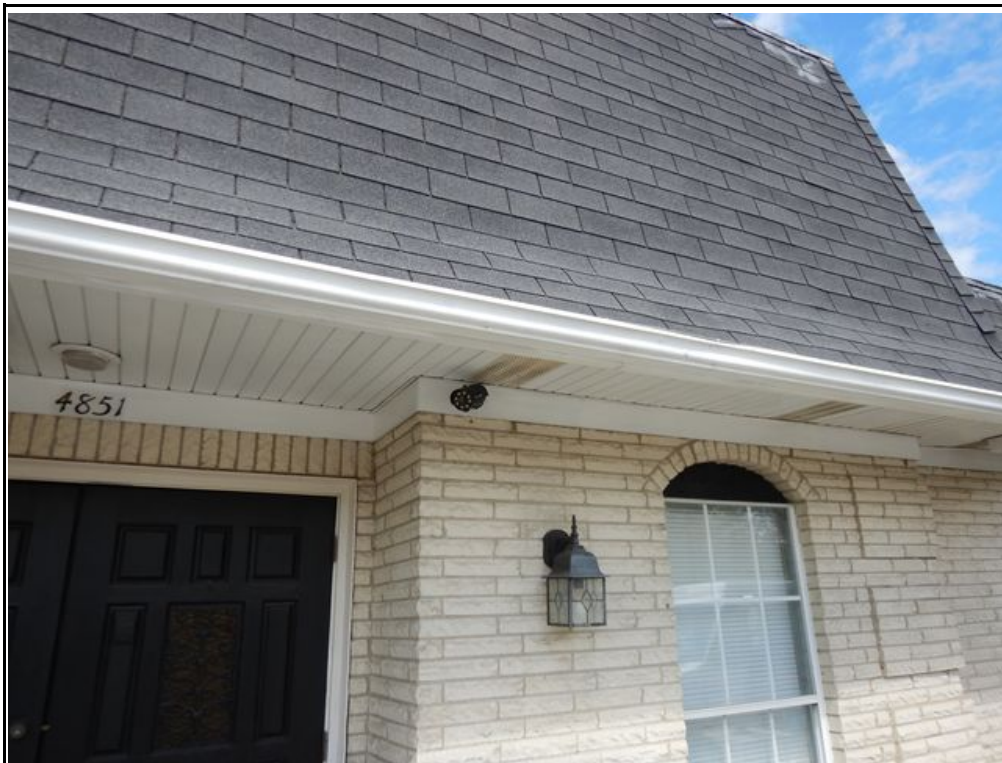
Photo Number

Clubhouse security camera and
lighting

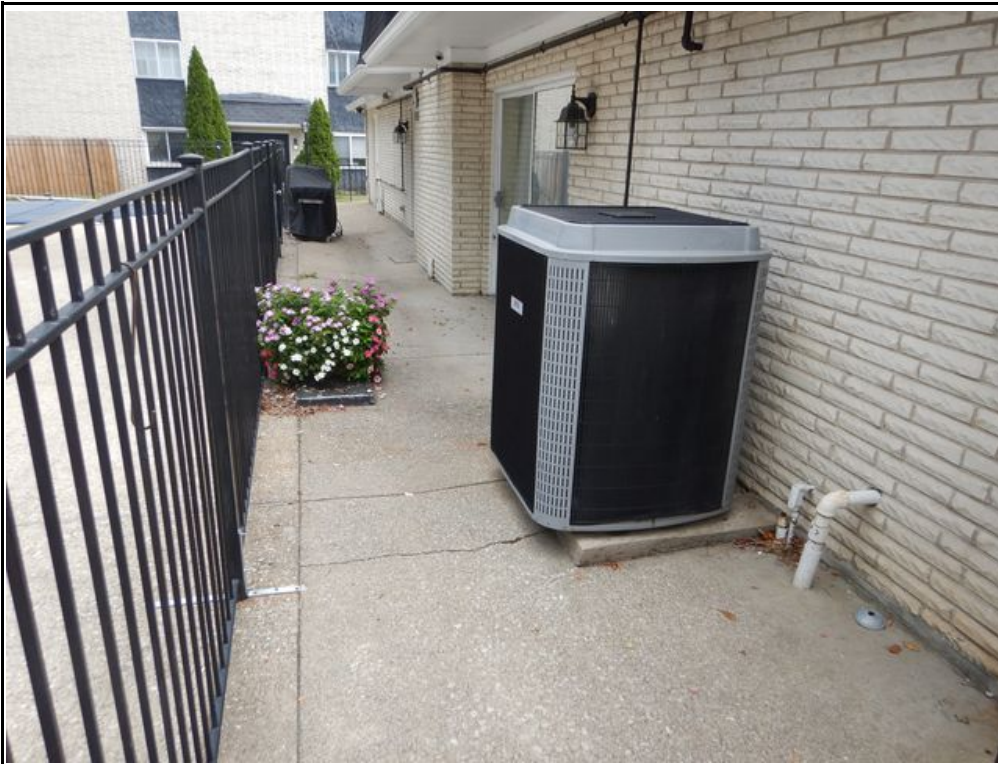
Photo Number

Clubhouse condensing unit

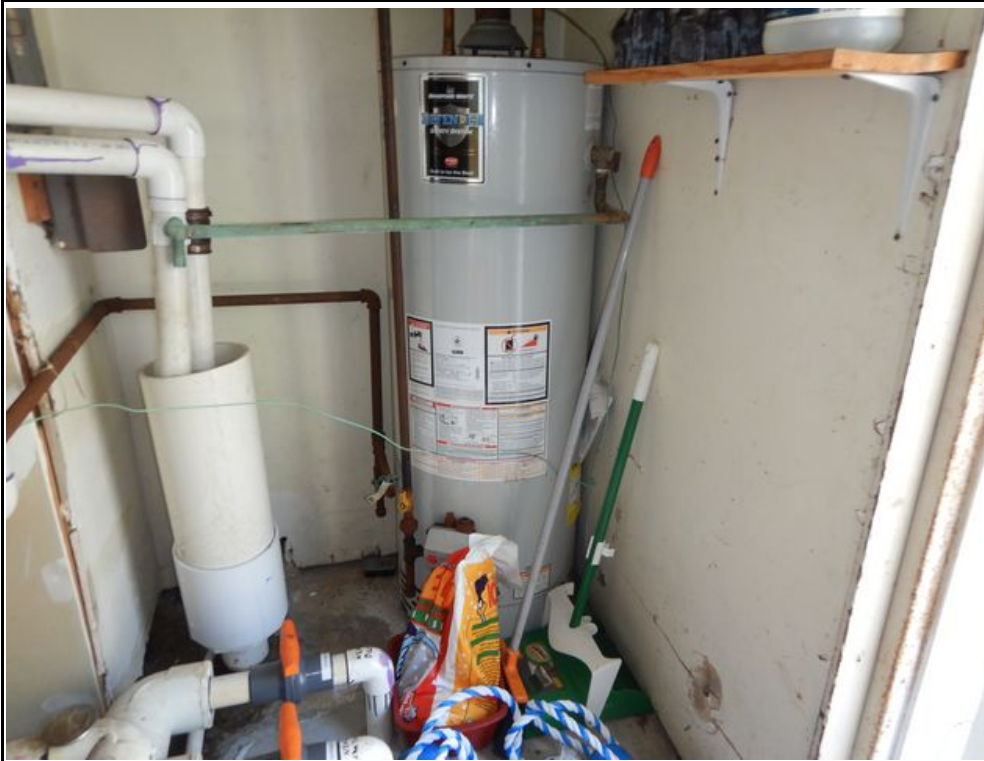
Photo Number

Clubhouse gas-fired water heater

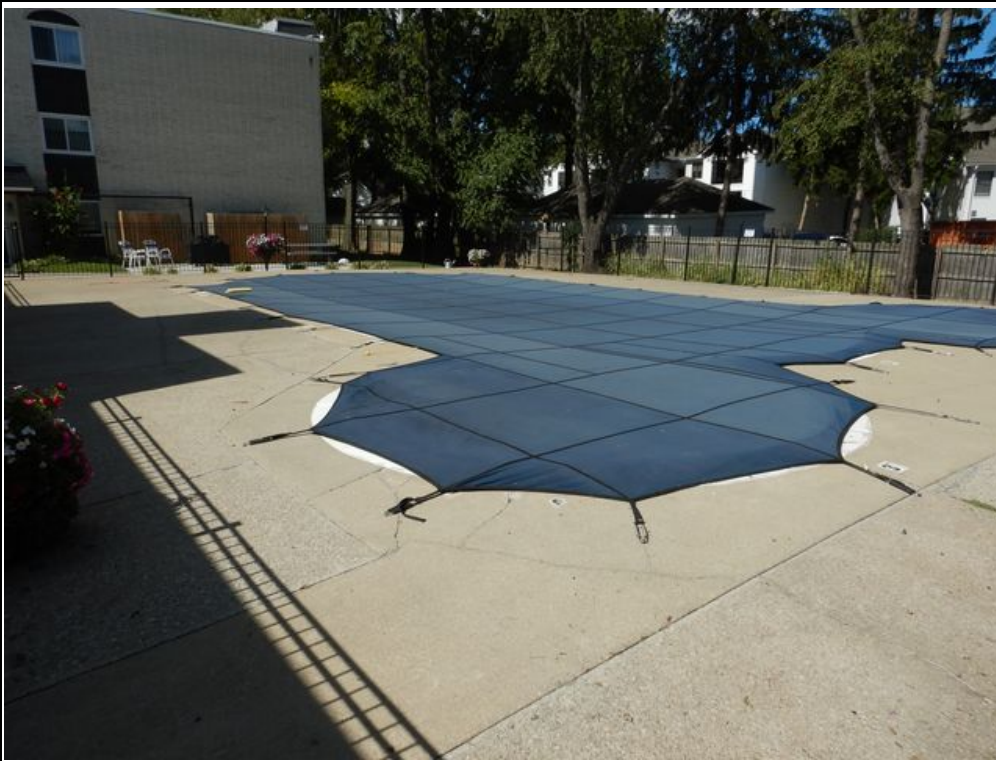
Photo Number

Pool deck and pool cover

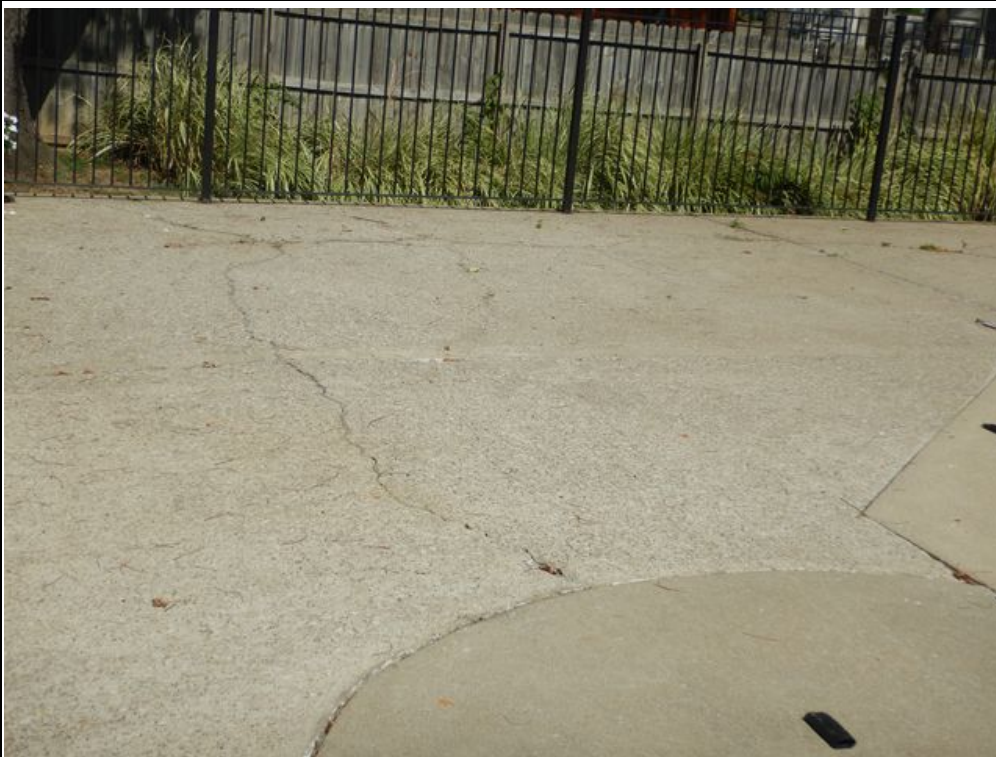
Photo Number

Pool deck with cracks

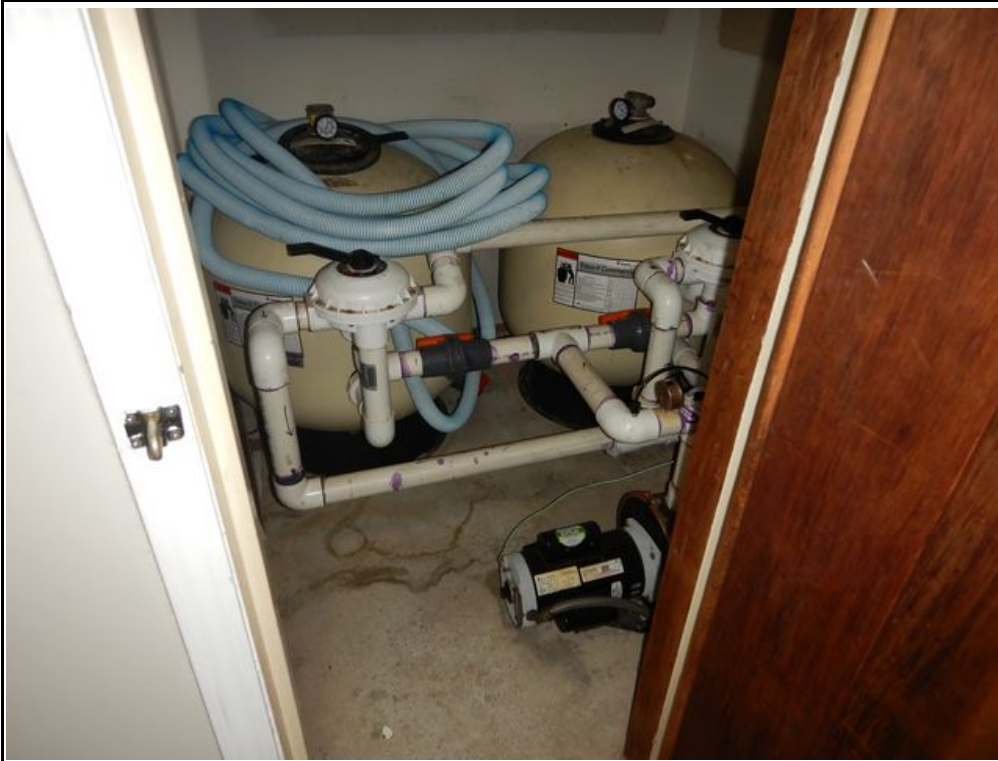
Photo Number

Pool equipment
